**SITE ASSESSMENT REPORT FOR THE
CALUMET AND HECLA POWER PLANT SITE
LAKE LINDEN, HOUGHTON COUNTY, MICHIGAN**

UNITED STATES ENVIRONMENTAL PROTECTION AGENCY

Date Prepared	December 7, 2010
Technical Direction Document No.	S05-0001-1003-030
Contract No.	EP-S5-06-04
Document Control No.	988-2A-AHLZ
WESTON START Project Manager	Daniel M. Capone
Telephone No.	517-381-5932
U.S. EPA On-Scene Coordinator	Ralph Dollhopf

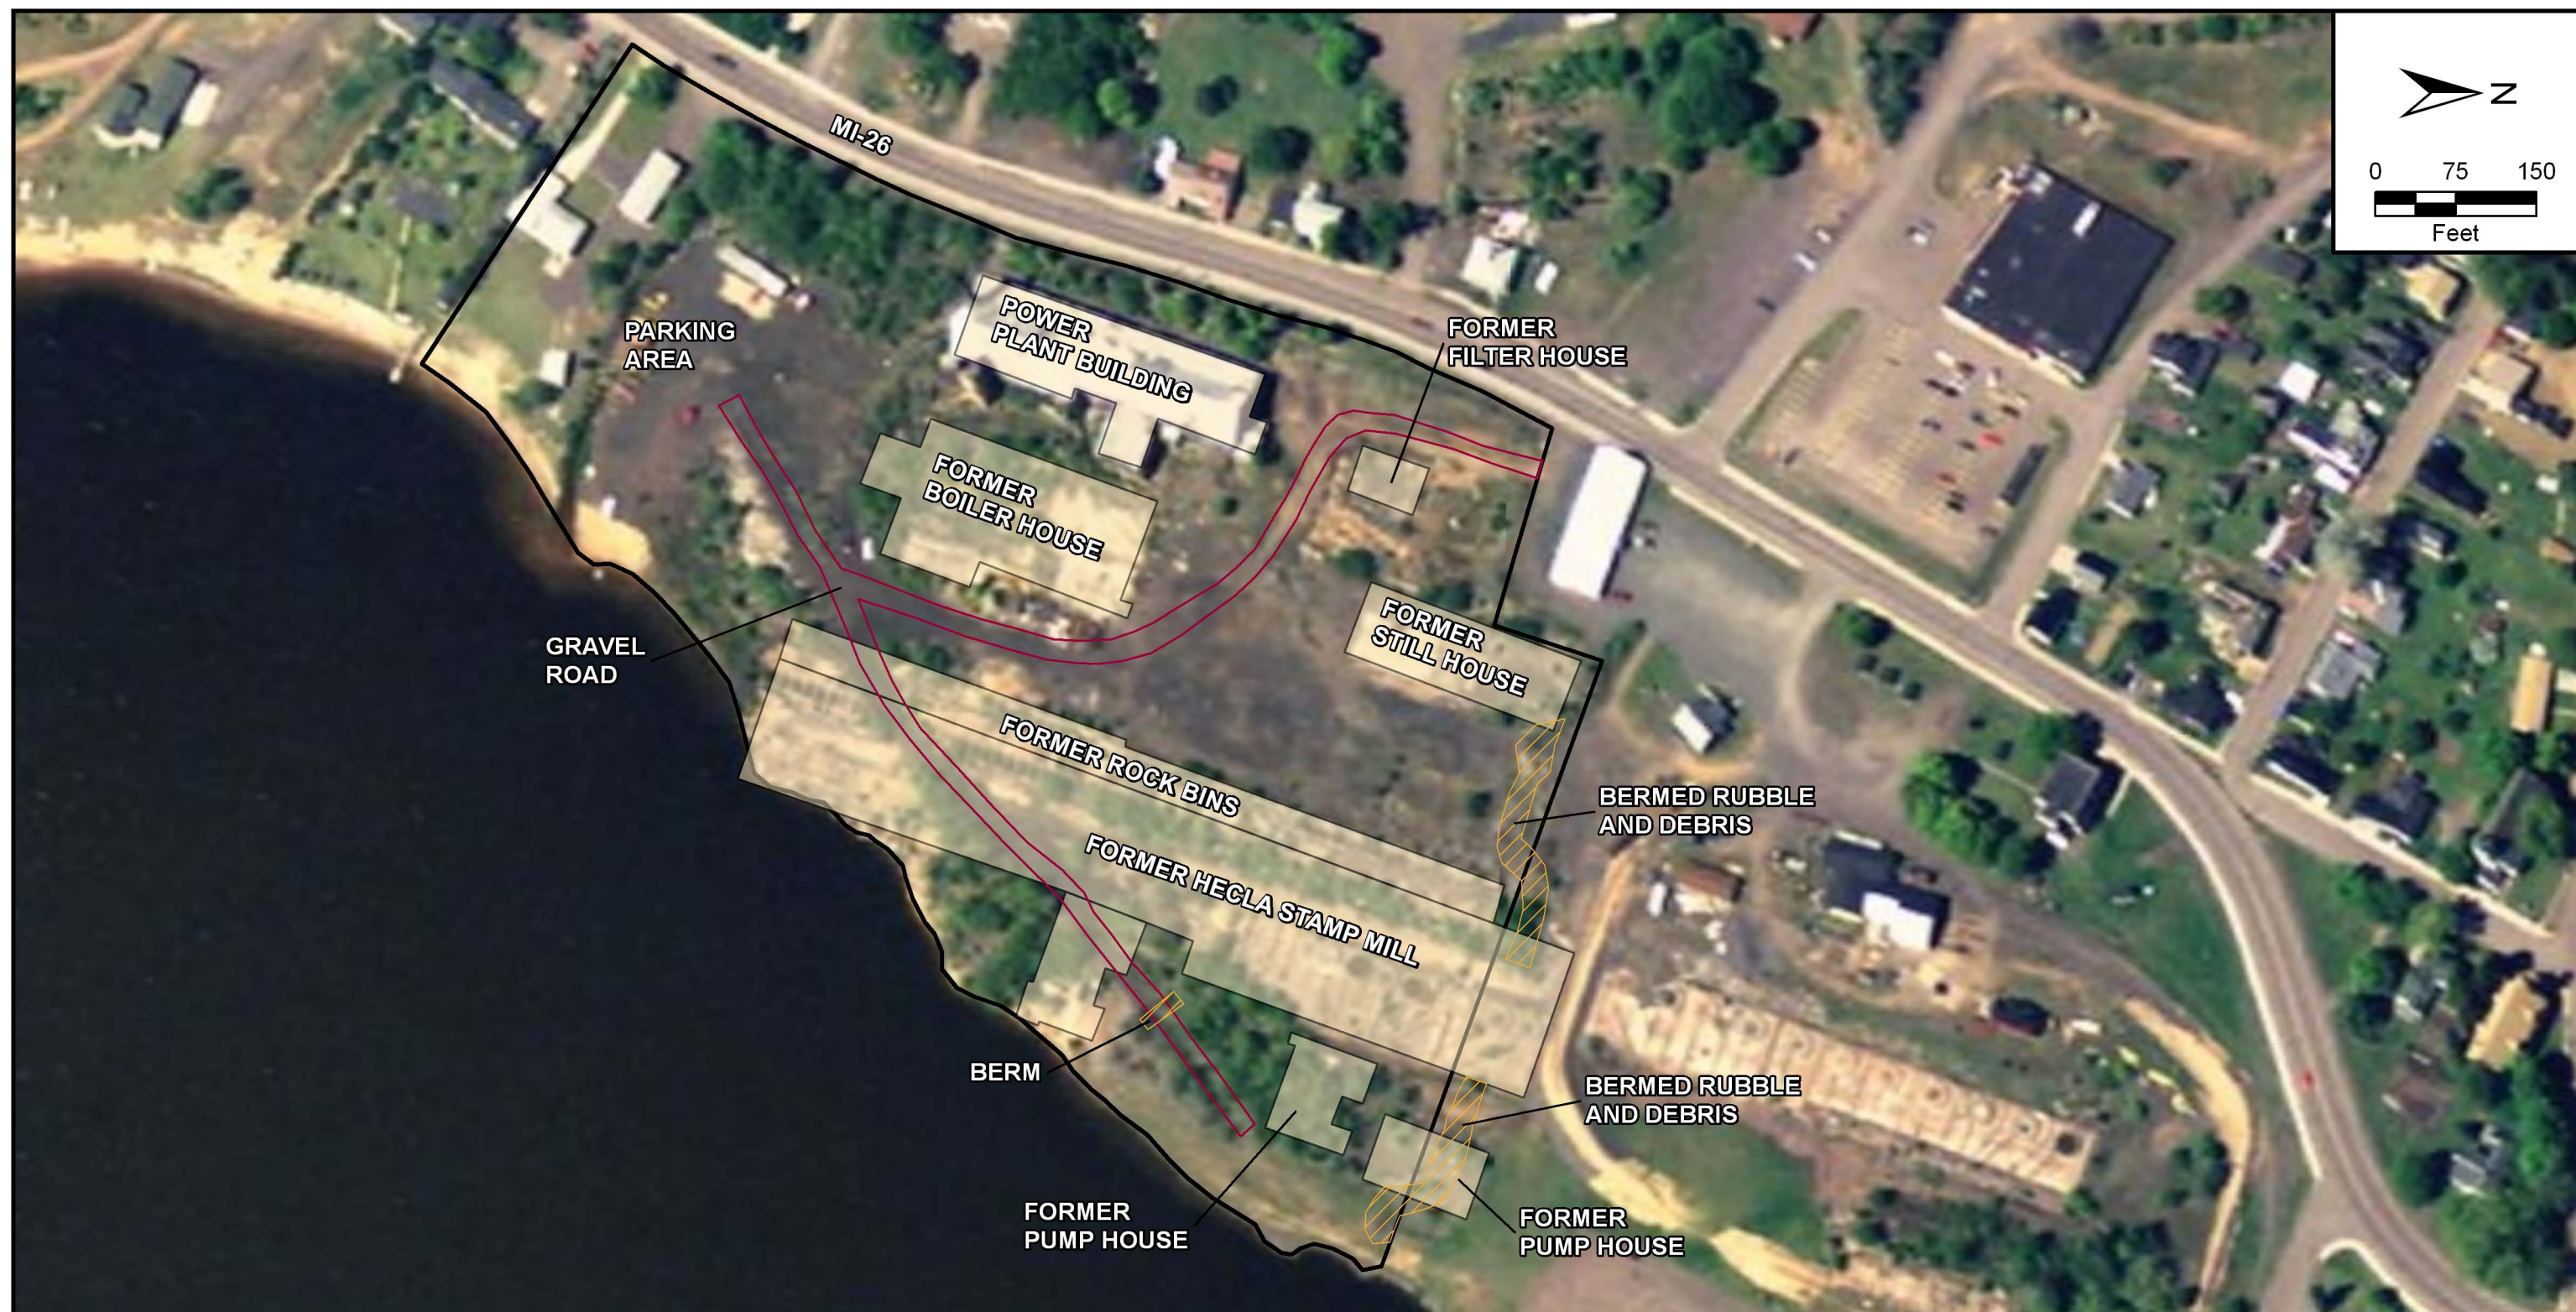
Figure 2-2

SITE LAYOUT MAP
 C & H POWER PLANT SITE
 LAKE LINDEN, HOUGHTON CO., MICHIGAN
 Created: July 2010

The property encompasses approximately 14 acres and contains one building - the former C&H Power Plant building. The exterior of the building is dilapidated, and historical file information indicates that local citations have been issued for "Dangerous Conditions" at the Site. In addition, the Site contains foundations and floors from buildings no longer present at the Site that present various physical hazards related to terrain and subsurface conduits. Remnants of the following former buildings are still present at the Site: boiler house, still house, filters house, Hecla stamp mill, and two former pump houses. In addition, the Site contains former rock bins and bermed rubble and debris piles. **Figure 2-2** shows the current features and the historical building locations.

The Site historically contained several primary buildings that included a power plant, a centrally located boiler house, and the Hecla stamp mill along the waterfront. Only the power plant building is currently present at the Site. Smaller buildings located north of the power plant and boiler house included a filter house and a still house. These buildings are no longer present at the Site, but their foundations still exist (**Figure 2-2**).

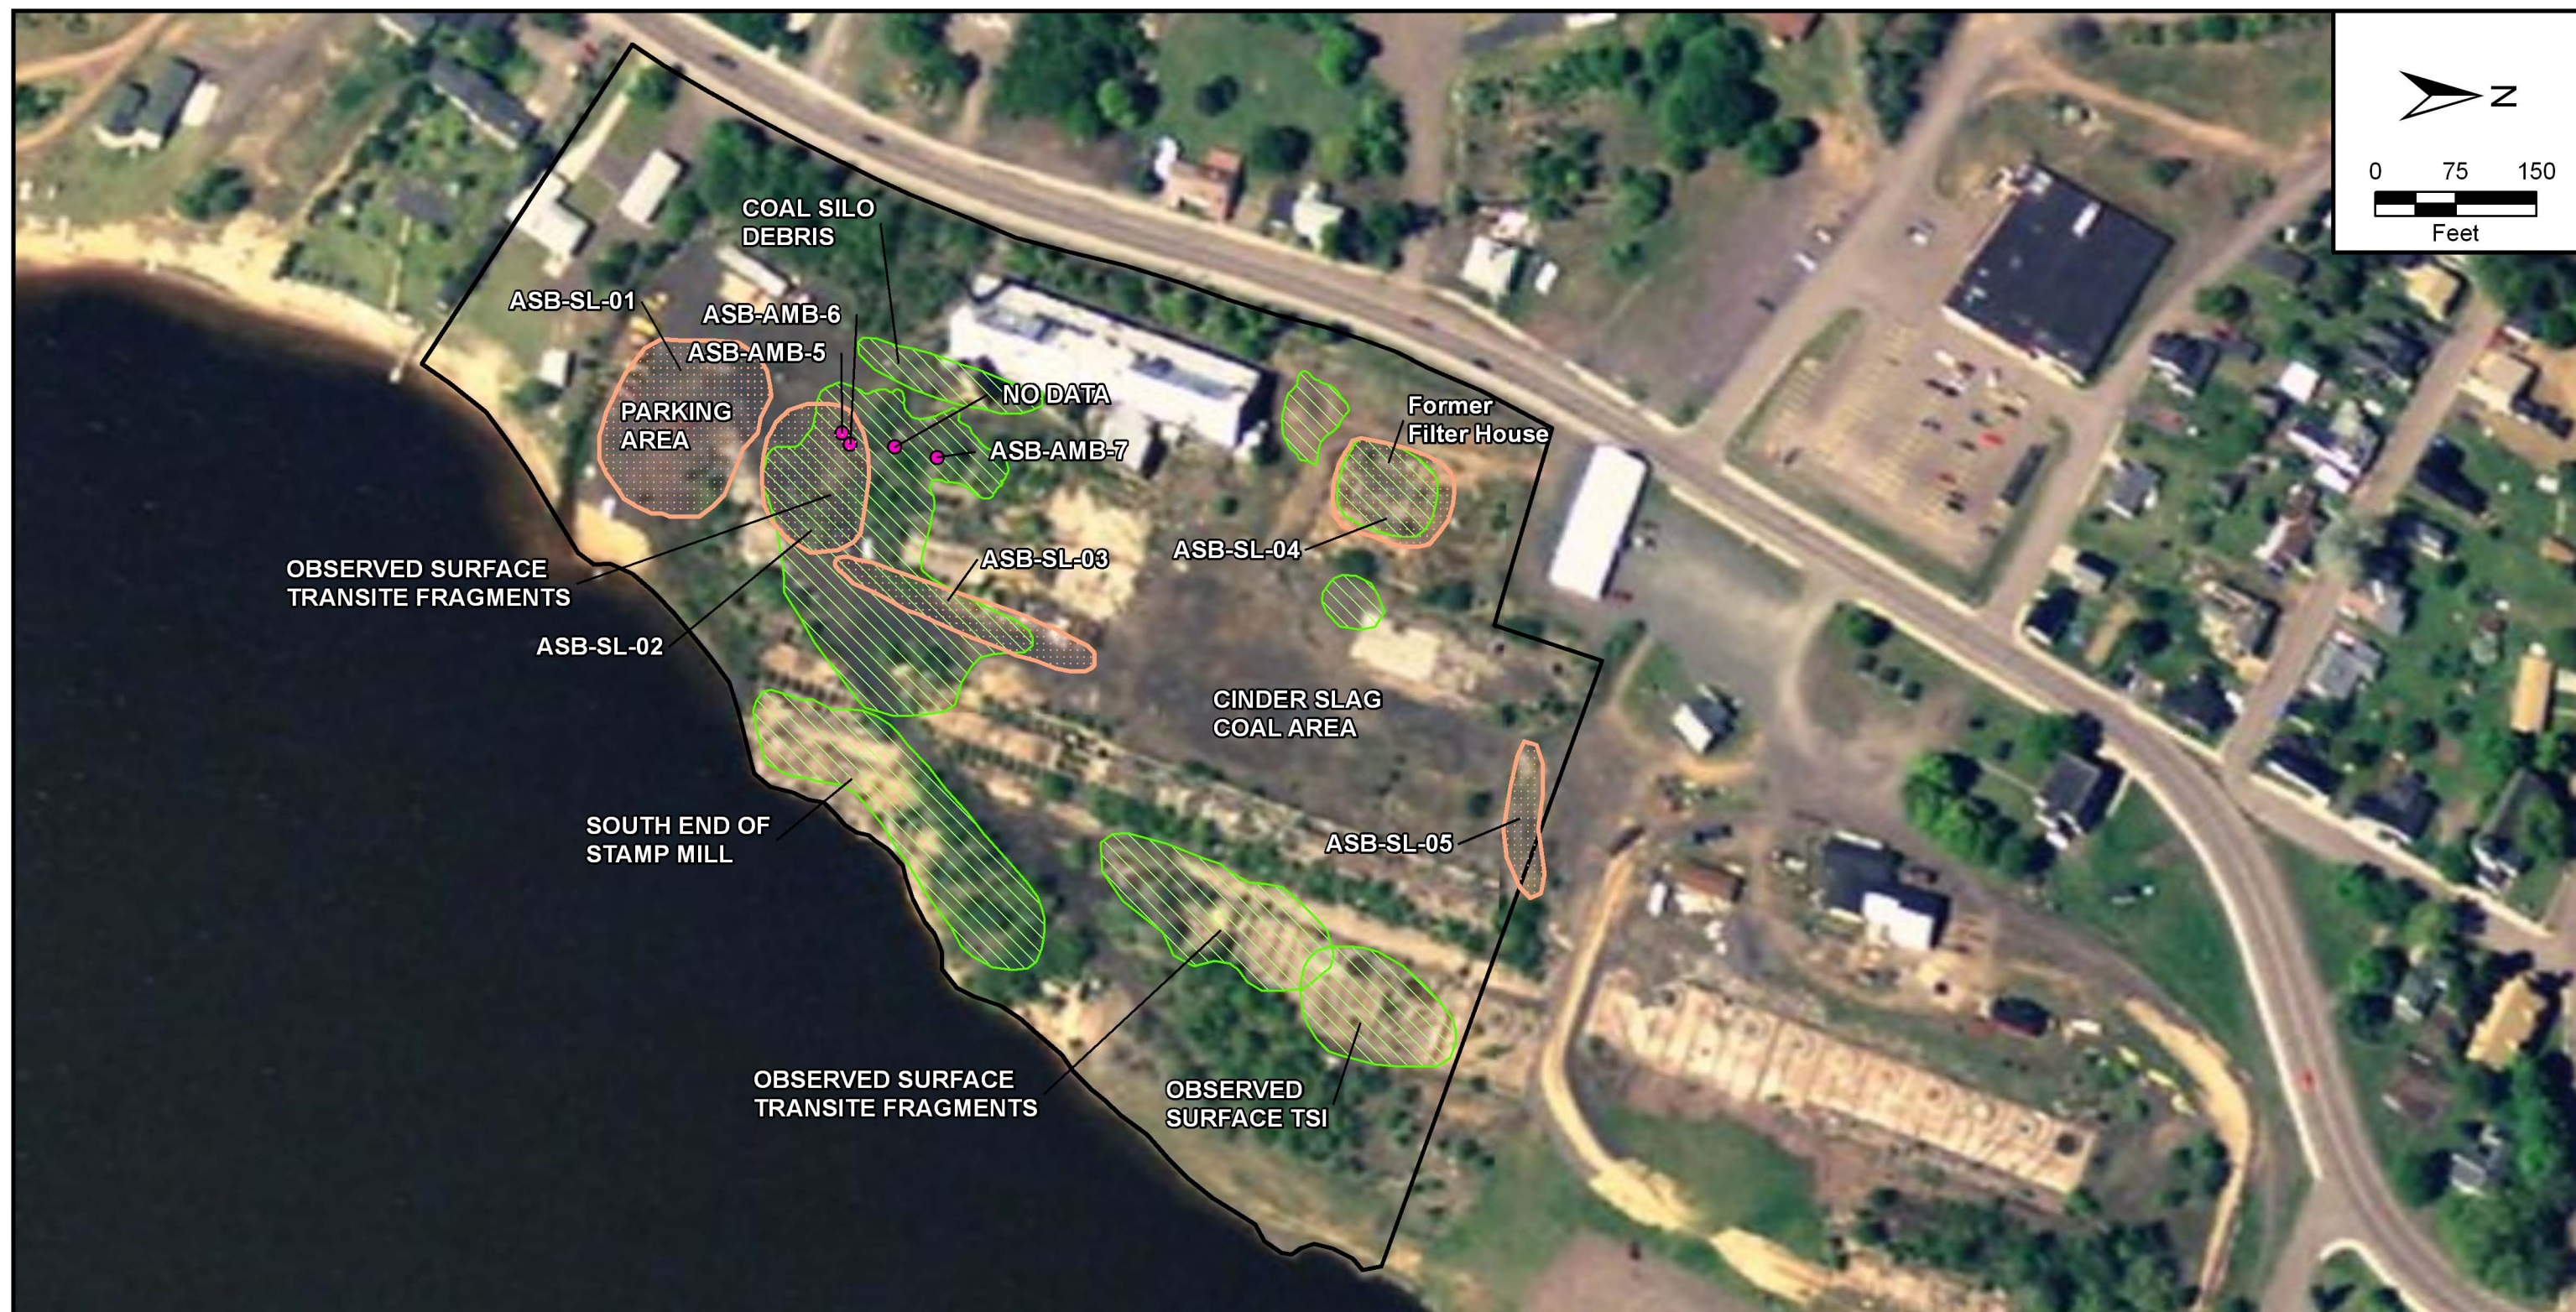
**EXTERIOR BULK ASBESTOS SAMPLING
LOCATIONS - MAY 2010**
C & H POWER PLANT SITE
LAKE LINDEN, HOUGHTON CO., MICHIGAN
Created: July 2010

Figure 3-2 shows the bulk asbestos sampling locations outside the power plant building. **Table 2** summarizes the analytical results for the samples and provides recommendations for each material sampled outside the power plant building.

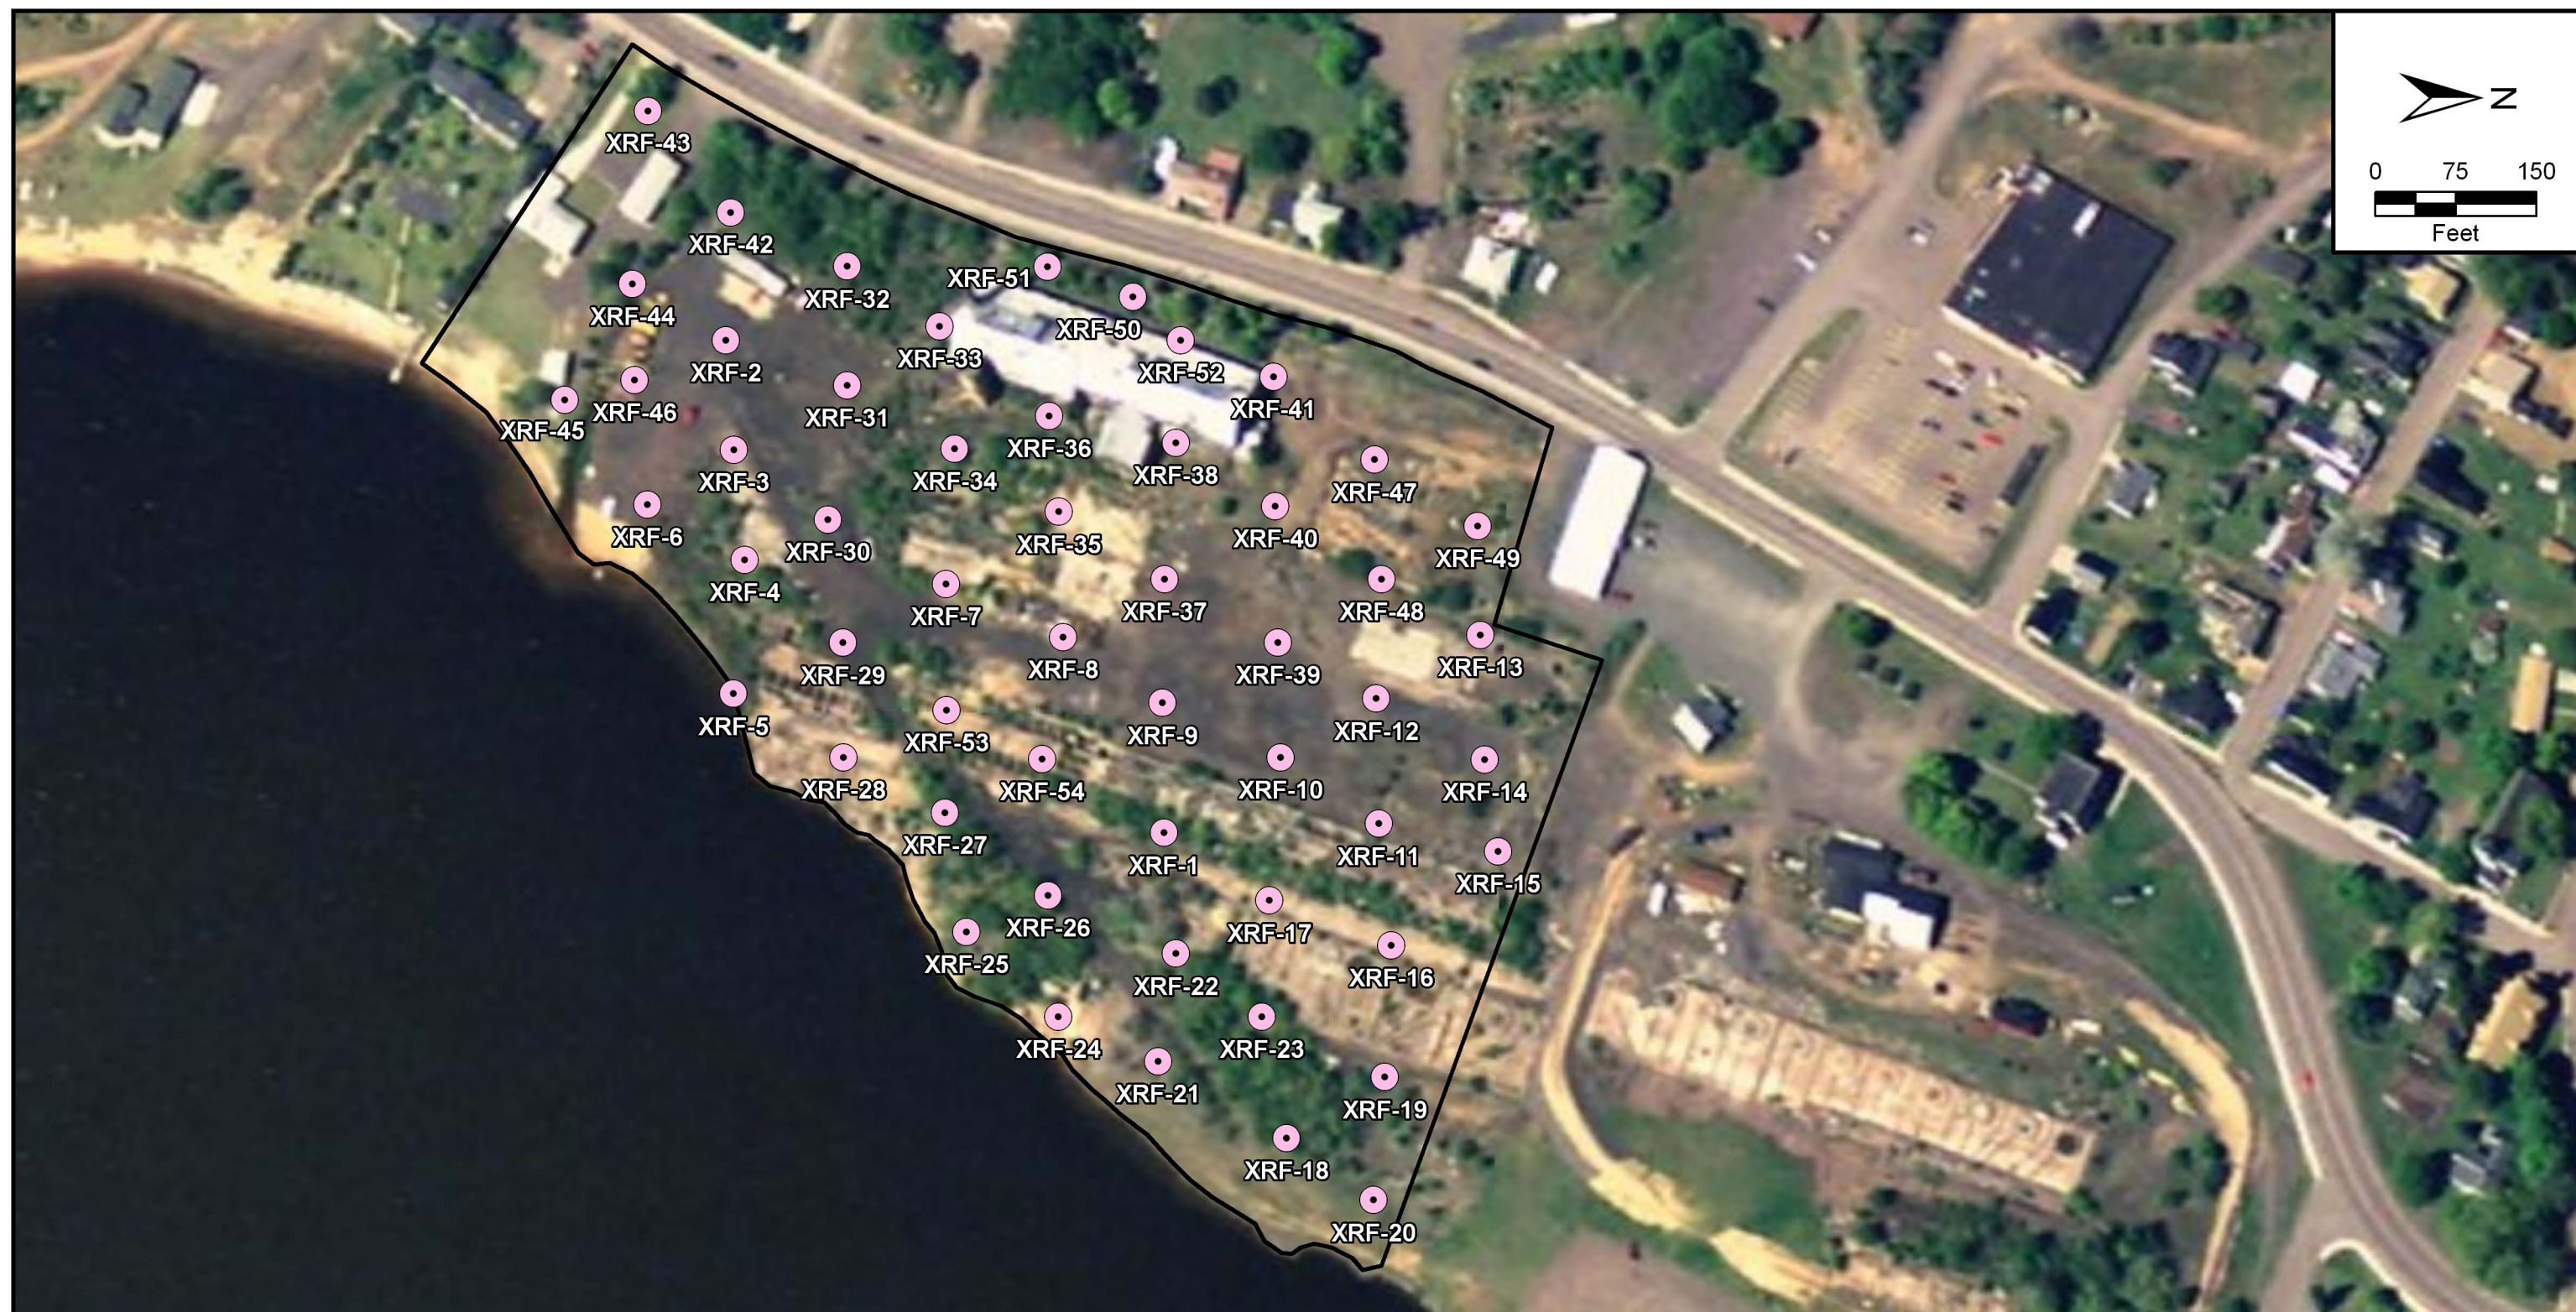
**EXTERIOR AIR SAMPLING ARRAY AND
ASBESTOS SOIL SAMPLING LOCATIONS -
MAY 2010**
C & H POWER PLANT SITE
LAKE LINDEN, HOUGHTON CO., MICHIGAN
Created: July 2010

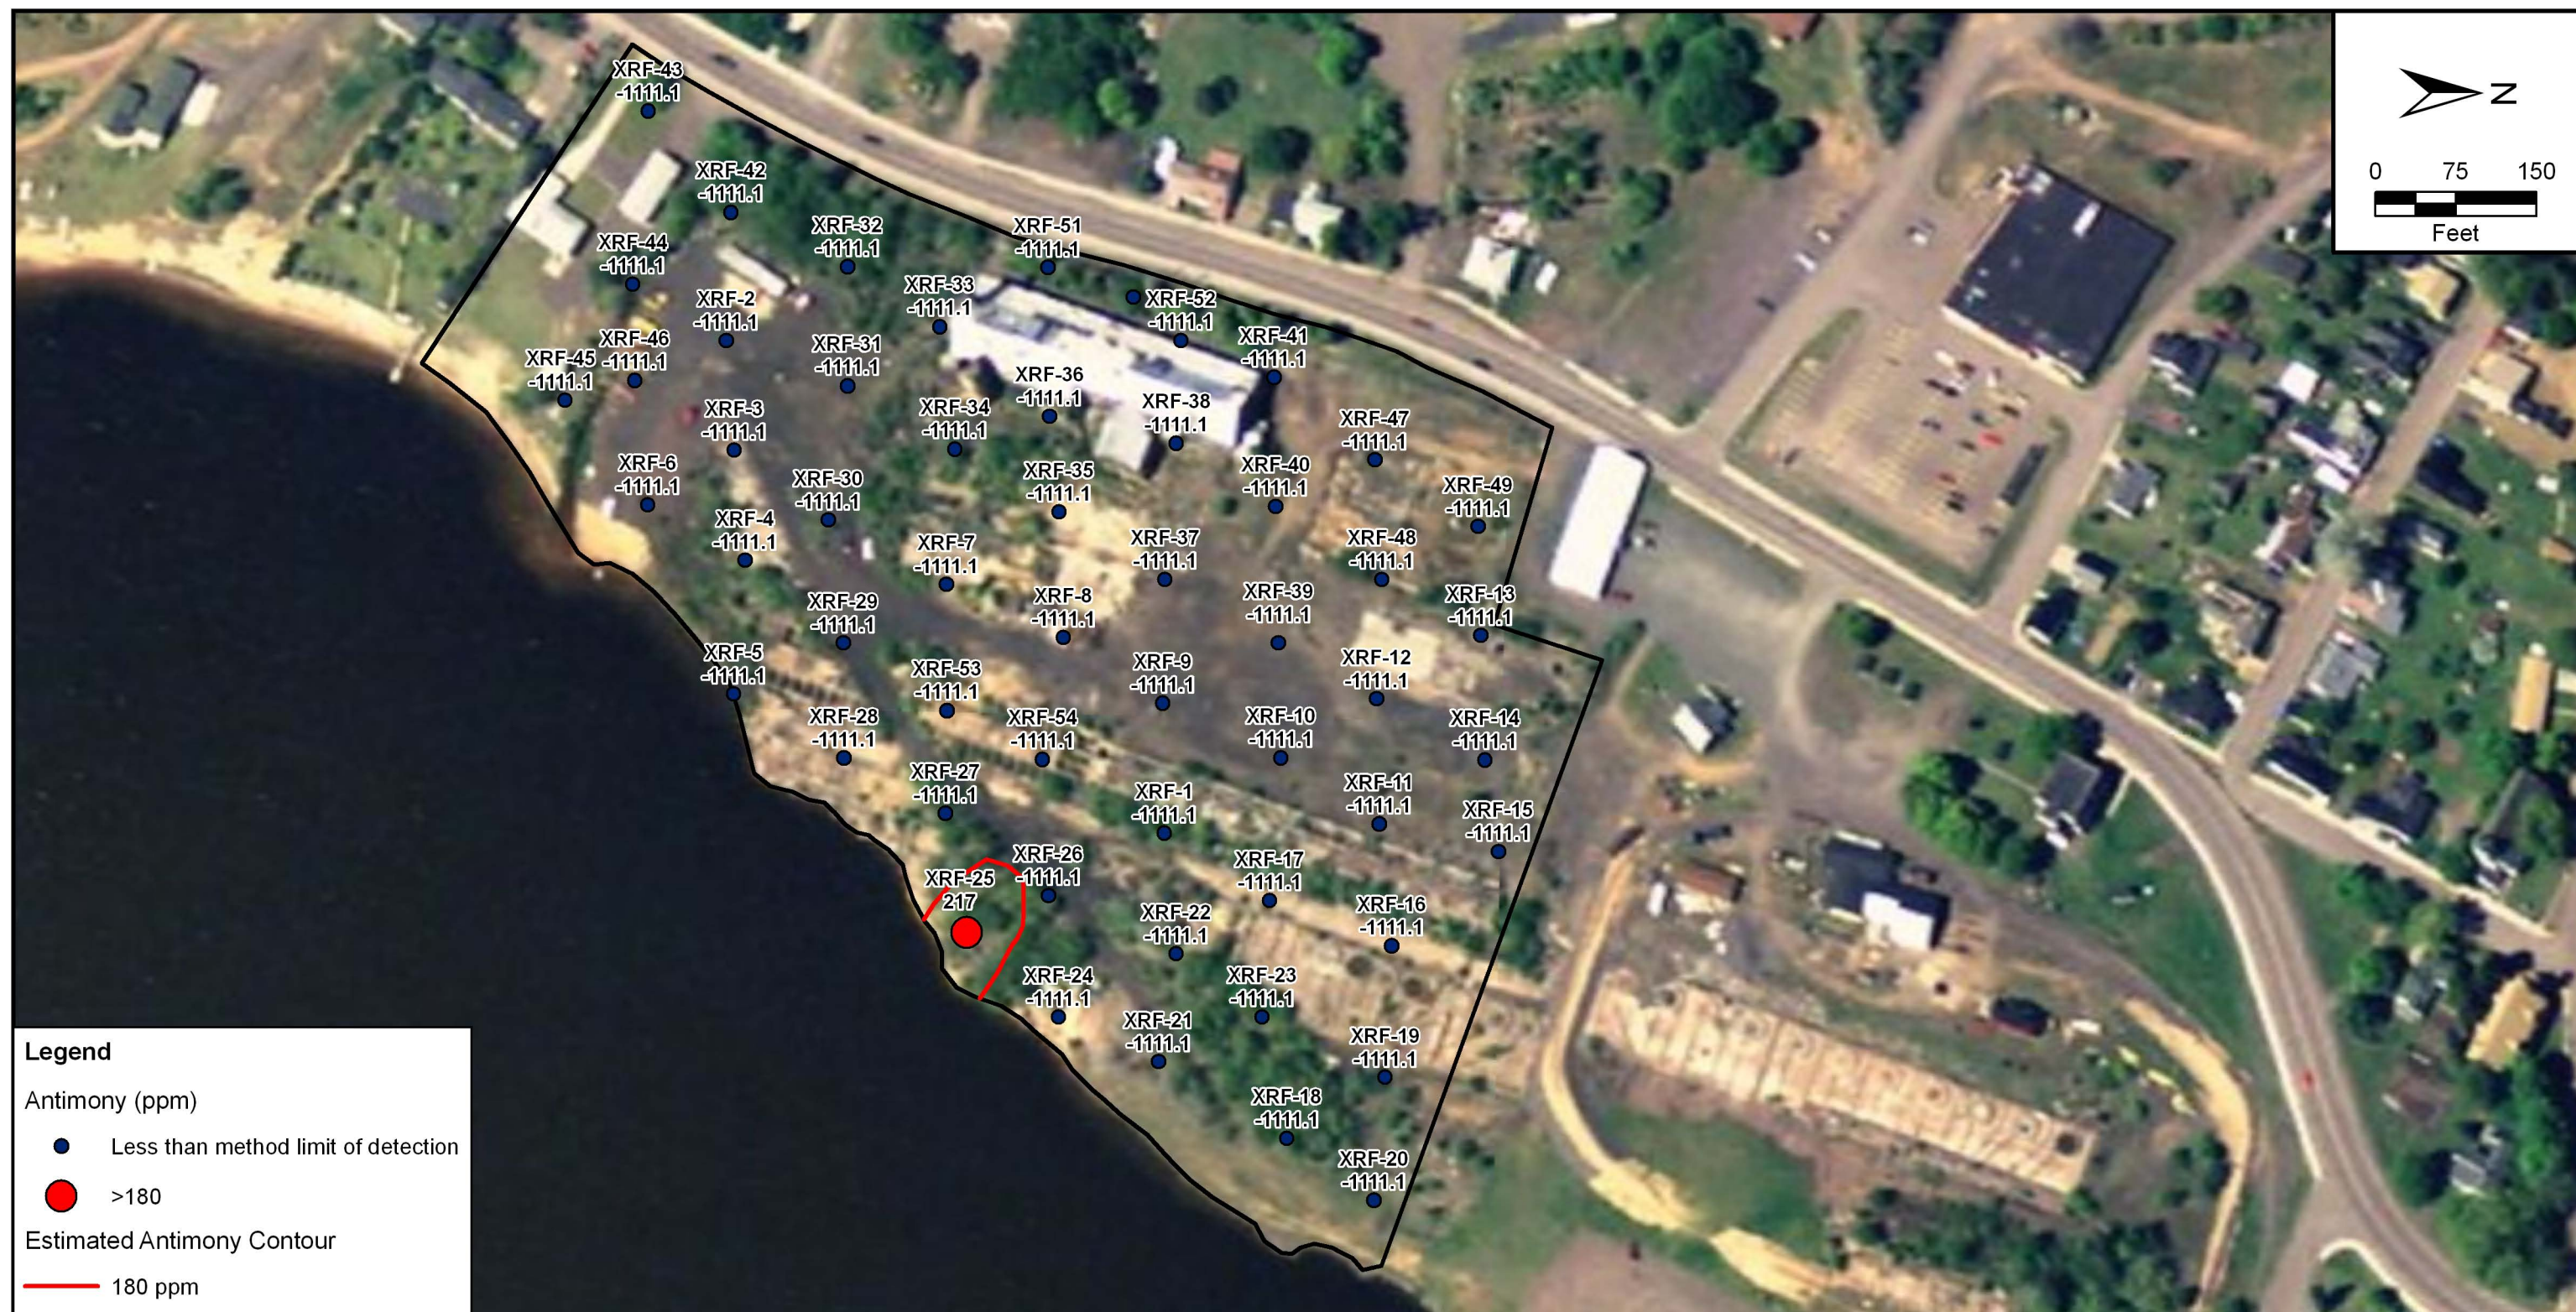
Figure 4-1

Note: -1111.1 = below the method limit of detection. This value is not recorded by the XRF instrument. The only detected antimony value was 217 ppm.

XRF SCREENING RESULTS - ANTIMONY - JUNE 2010
 C & H POWER PLANT SITE
 LAKE LINDEN, HOUGHTON CO., MICHIGAN
 Created: July 2010

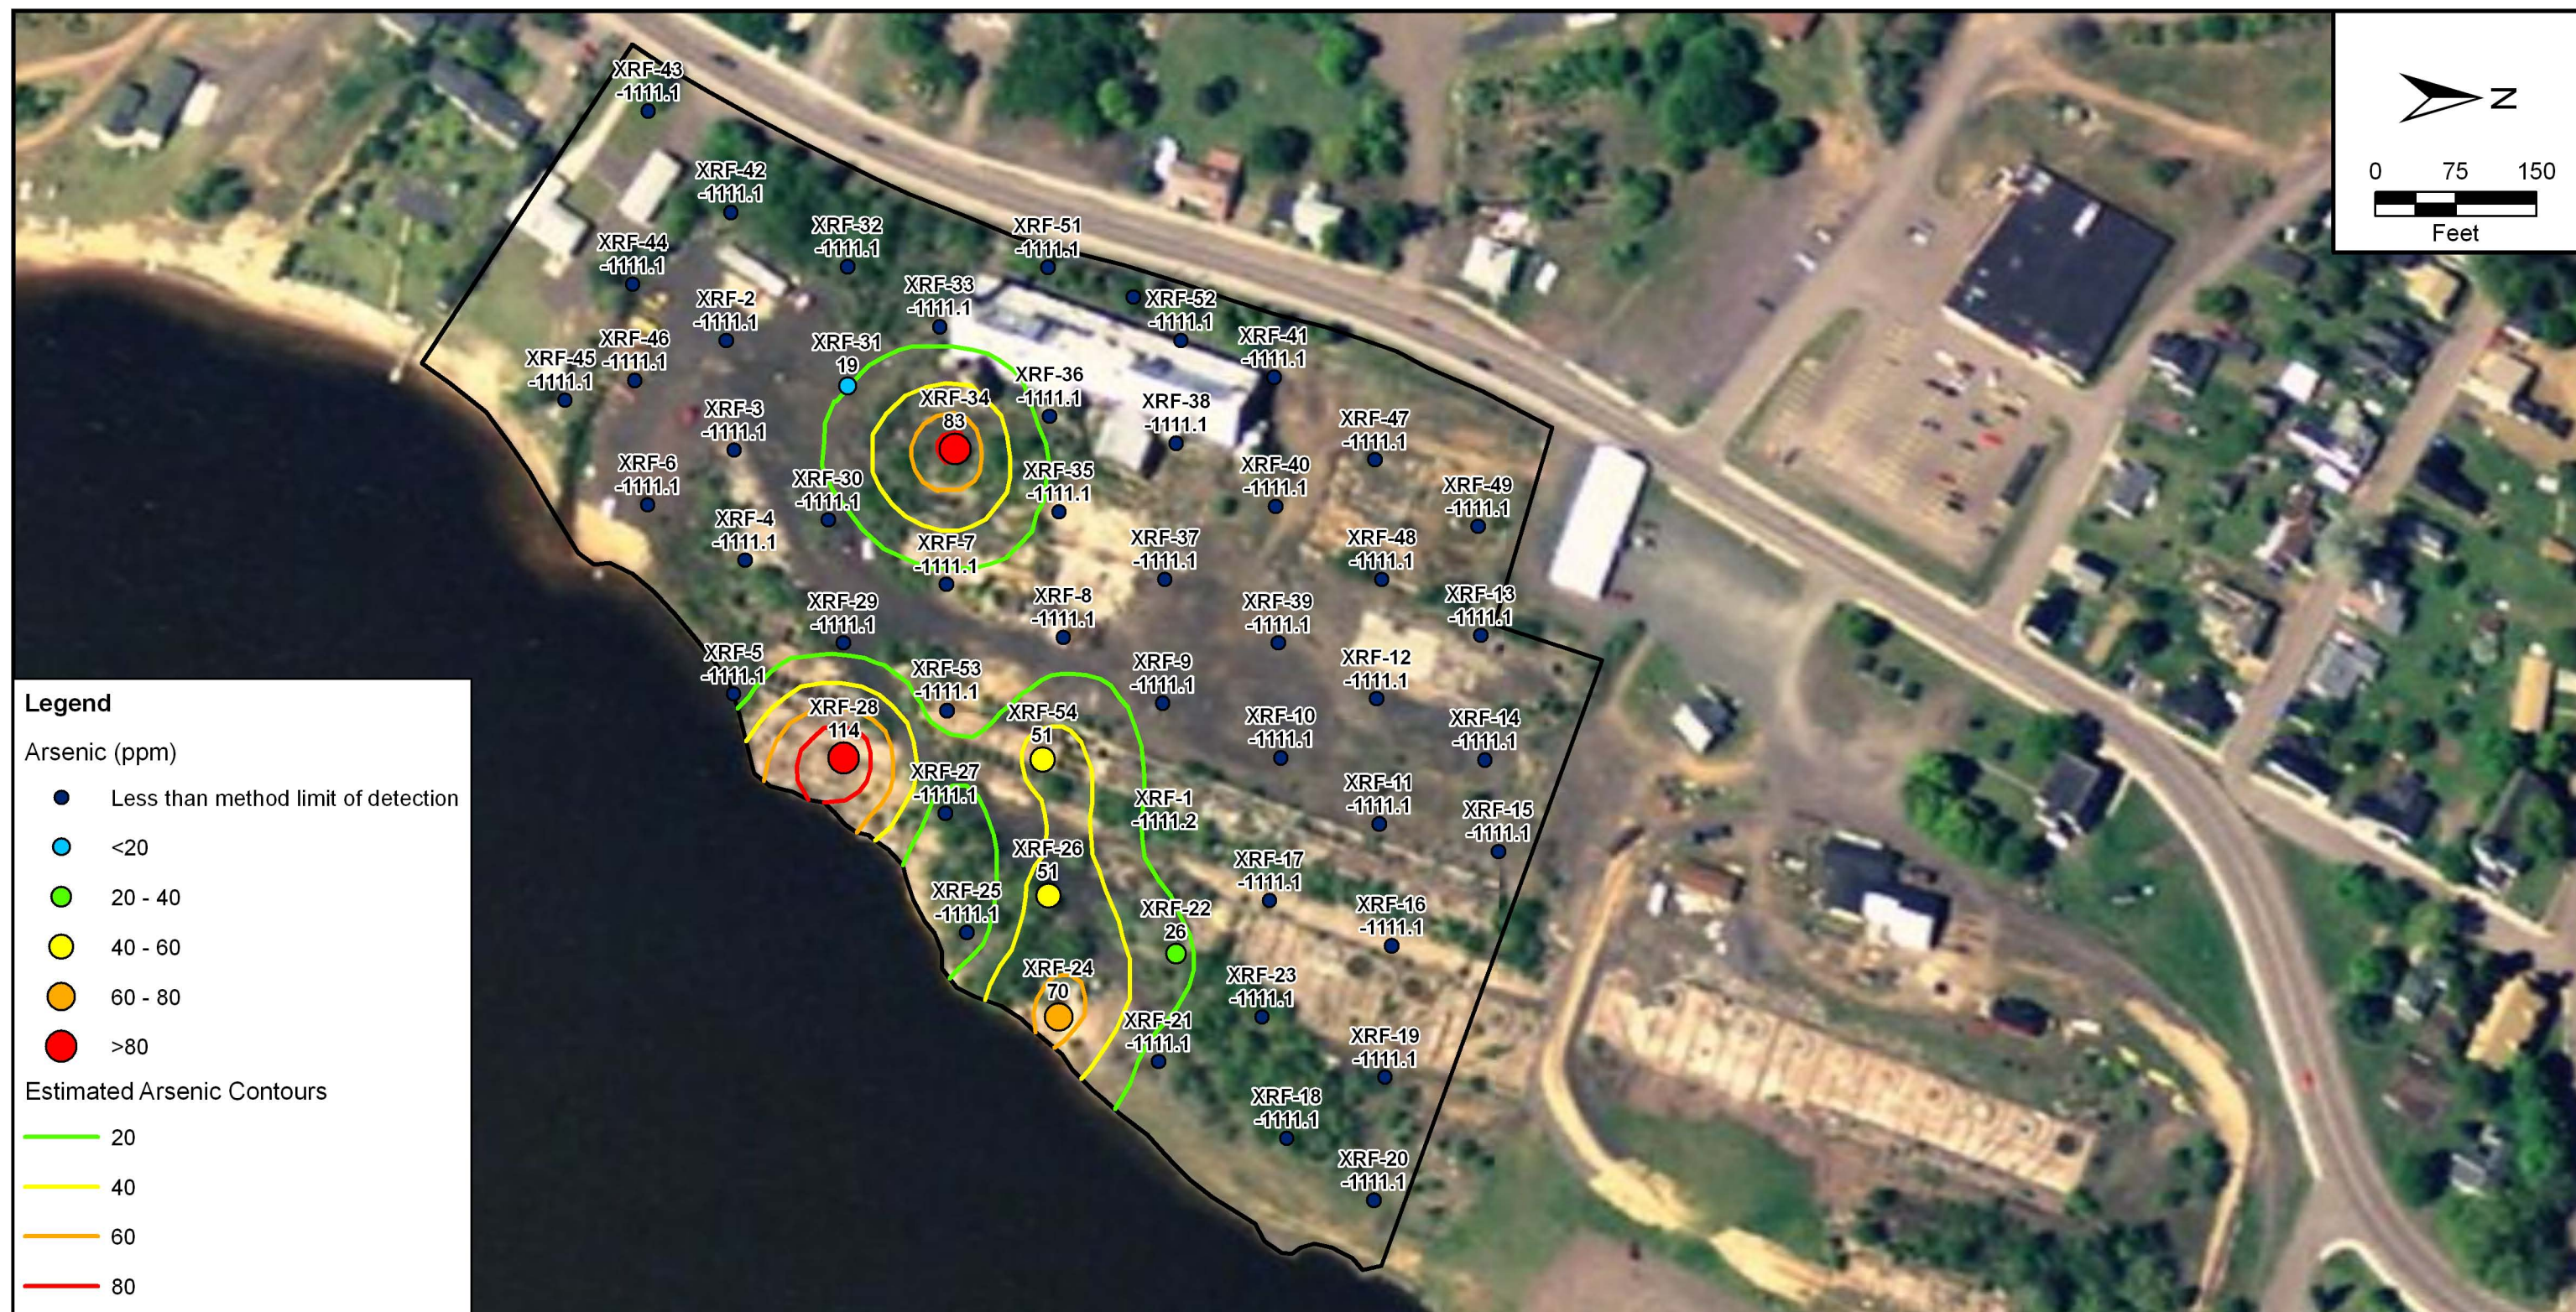
Figure 4-2

Note: -1111.1 = below the method limit of detection. This value is not recorded by the XRF instrument. The lowest detected arsenic value was 19 ppm.

XRF SCREENING RESULTS - ARSENIC - JUNE 2010
C & H POWER PLANT SITE
LAKE LINDEN, HOUGHTON CO., MICHIGAN
Created: July 2010

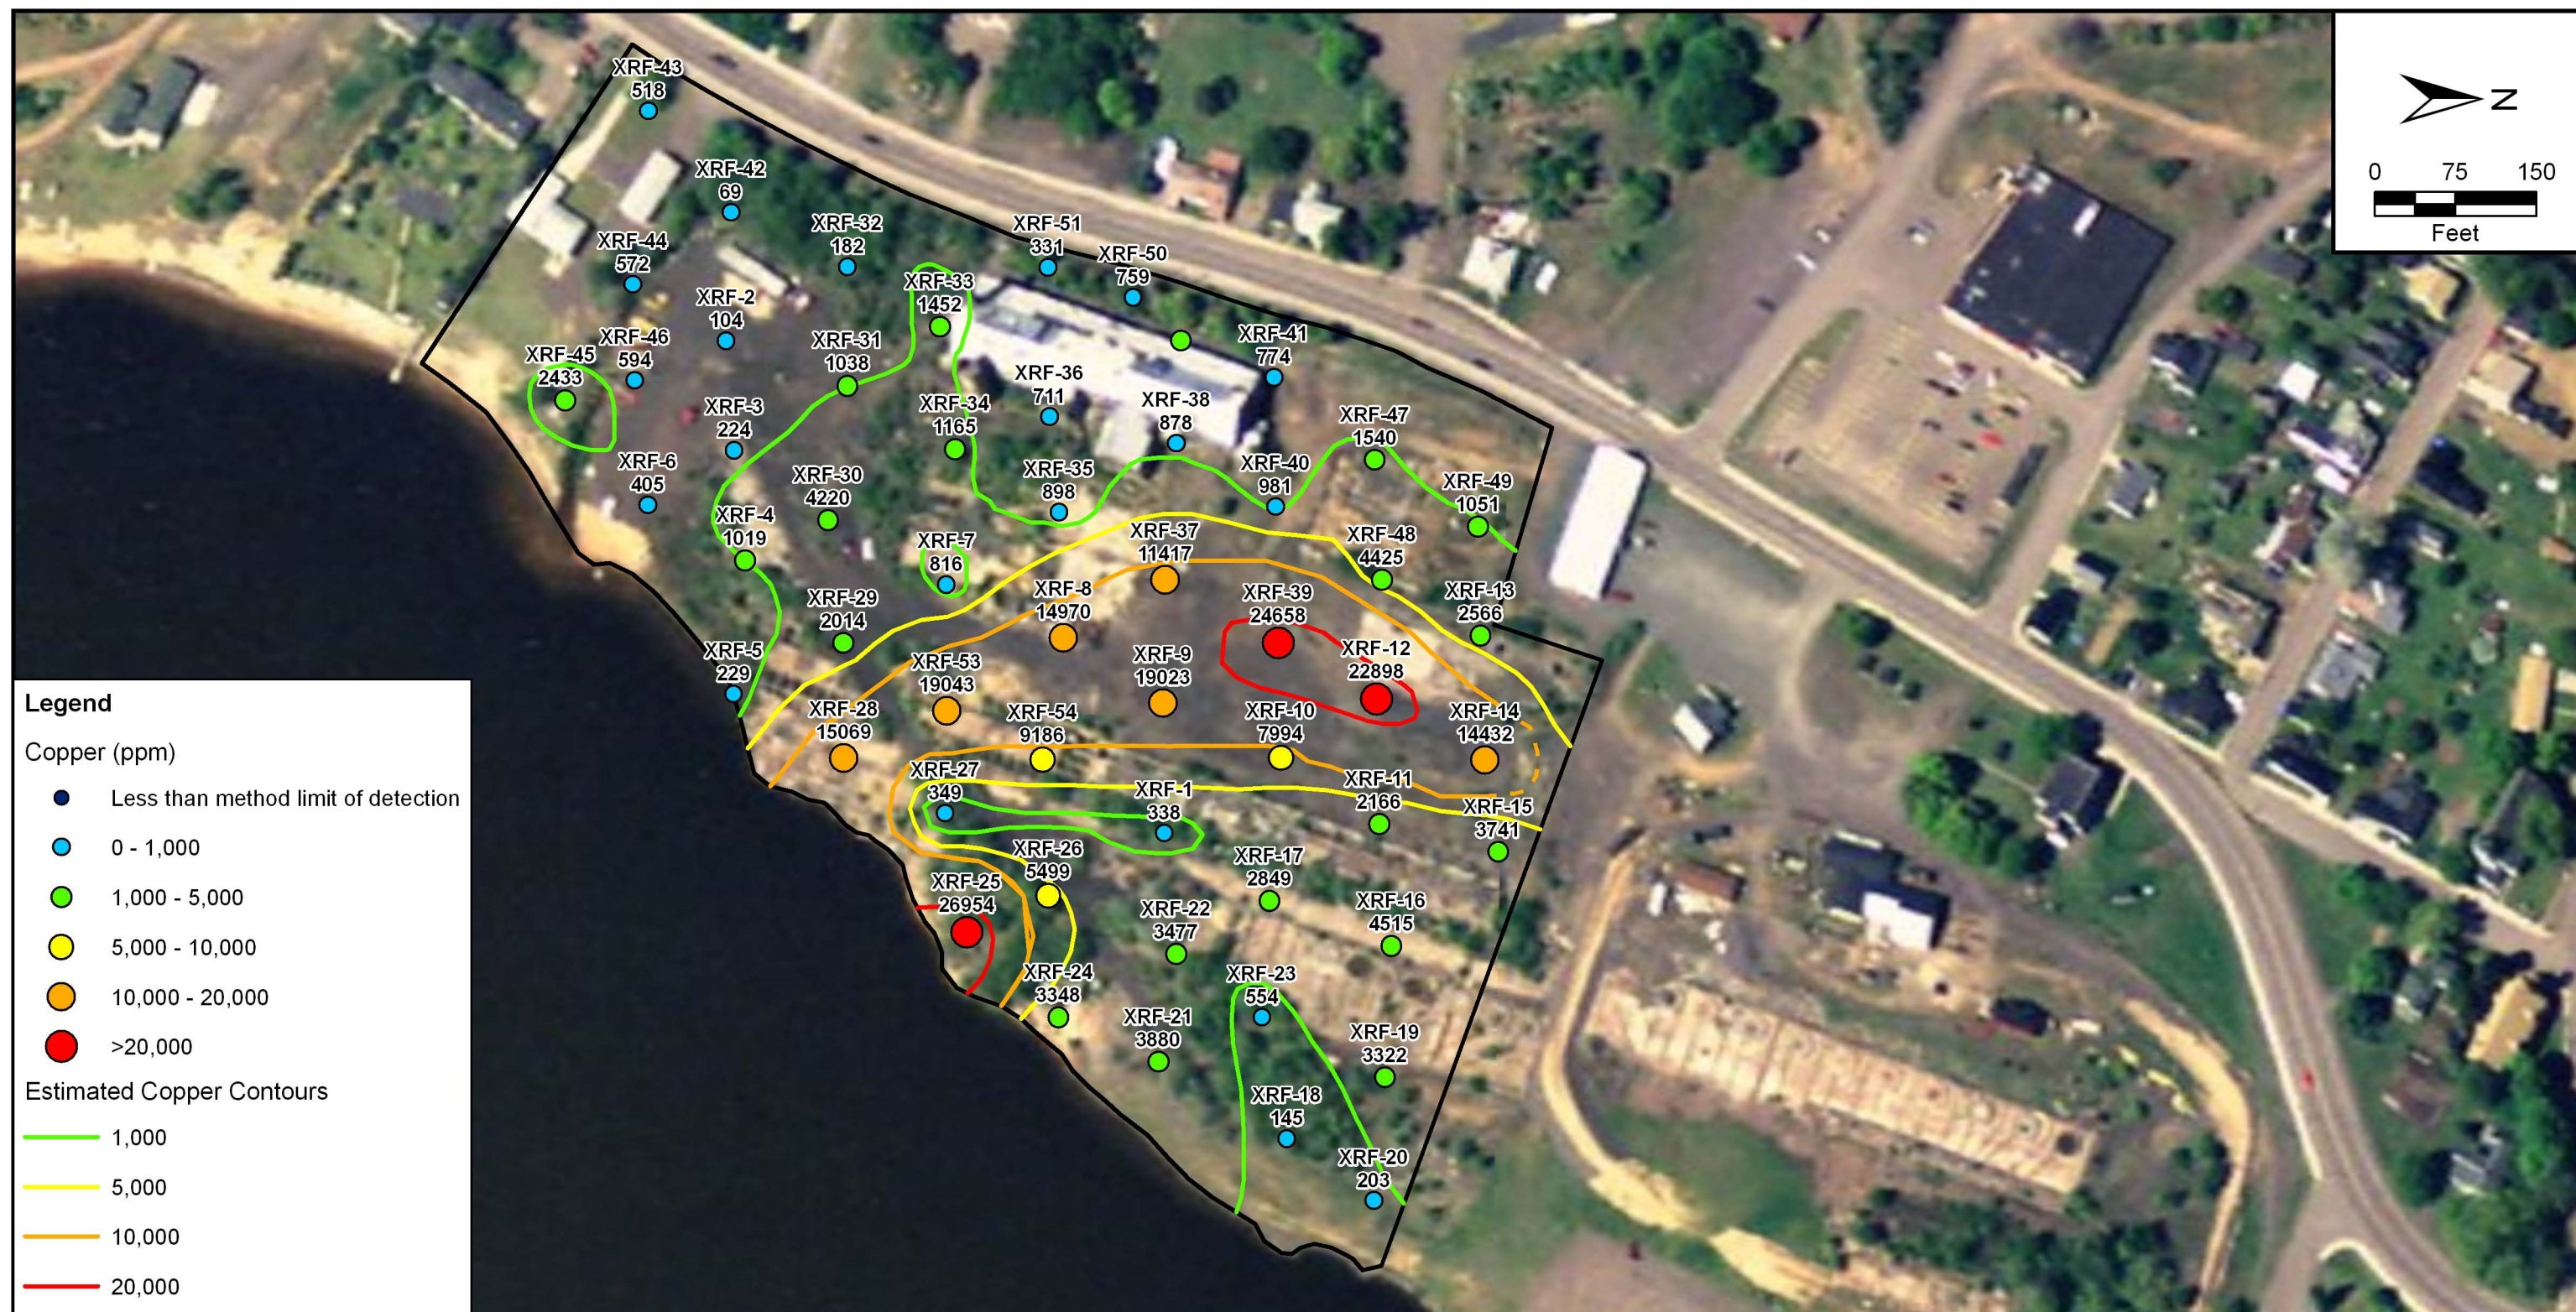
Figure 4-3

XRF SCREENING RESULTS - COPPER - JUNE 2010
 C & H POWER PLANT SITE
 LAKE LINDEN, HOUGHTON CO., MICHIGAN
 Created: July 2010
